OF THE
BEAR CREEK LAKE AREA
COLORADO

| REPORT DOCUMENTATION PAGE | PEAD INSTRUCTIONS BEFORE COMPLETING FORM |
|--|--|
| Cultural Overview of the Bear Creek Lake Area. | Final . |

August 25, 1980

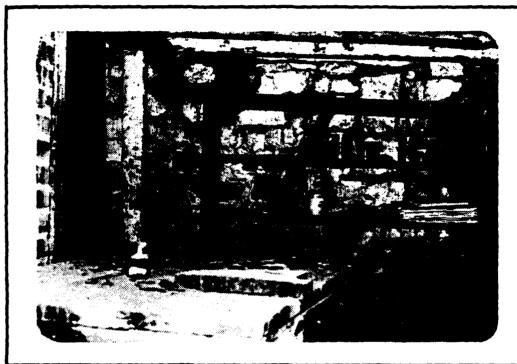
the same stone as the foundation and are mortared (Figure 15). As previously mentioned, a fairly modern brick chimney is centered in the basement. The floor of the basement is also of sandstone. Due to the extensive weathering, it was not possible to determine if it had been mortared in place.

Figure 15. Basement of the Ticen House showing stone and mortar along north wall.
